**April 2016**A16040E Version 1

## Concentrated Sunlight Can Cause Melted Plastic Body Parts and Trim Pieces

General Information

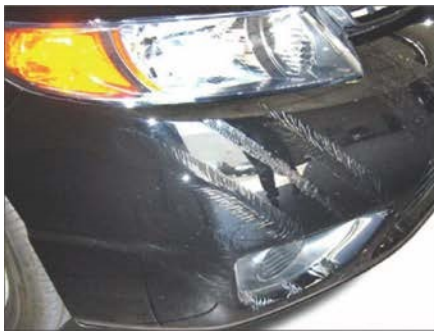
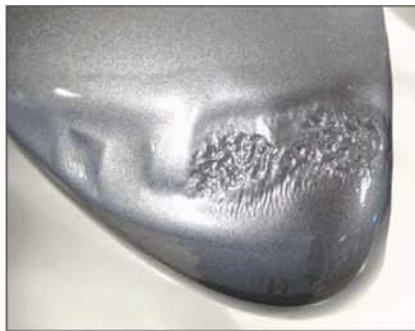
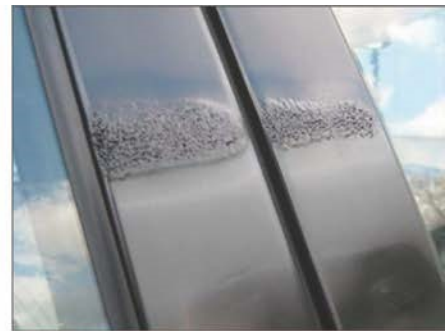
Although it's rare, concentrated sunlight forms when sunlight reflecting off the glass of a nearby building focuses into an intense beam. Think of it like focusing a magnifying glass. This beam is hot enough to fry heavy-duty materials such as residential vinyl siding as well as plastic parts on automobiles.

Typical damage will look like rows or strips of melted or wrinkled paint on large body parts, while smaller trim pieces will look warped or melted.

Keep in mind this sort of damage is strictly environmental and **isn't** covered by warranty.
